Homeowner's Guide

My Safe Florida Home Program

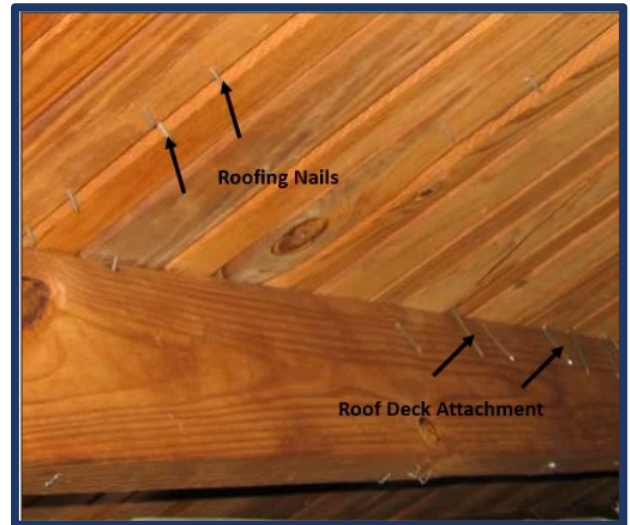
Improvement 3.0 – Roof Deck Attachment

The Roof Deck Attachment can be improved by installing additional nails or longer nails to bond the roof sheathing (most commonly: plywood sheets) to the trusses or attic rafters.

When installing a roof to the current code, a licensed Roofing Contractor will ensure the roof sheathing (e.g., plywood) is nailed down to the trusses or rafters with the proper nails and spacing. This helps hold the roof deck to the trusses/rafters in the event of a windstorm and should ensure it qualifies for the proper windstorm mitigation credit.

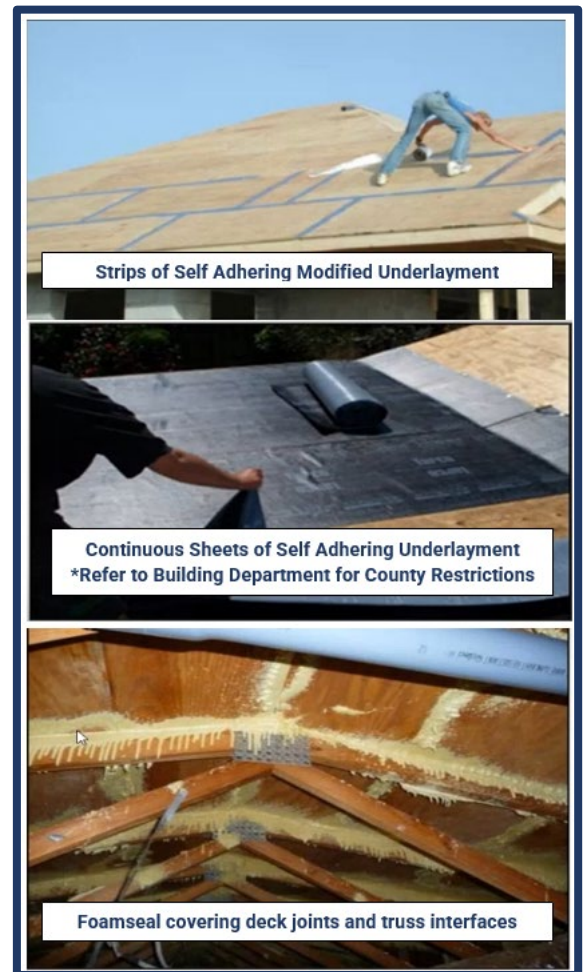
Improvement 4.0 – Secondary Water Resistance (SWR)

A Secondary Water Resistance (SWR) is an underlayment material that is self-adhered (peel-and-stick) and positioned directly to the roof deck to prevent water intrusion. This material can be full roof coverage, seam-tape (a 6" wide roofing tape covering all the seams of the roof deck material), or cell spray foam adhesive used in the attic space which seals every seam of the roof deck and on either side of the trusses or rafters.

1. At the time of reroofing, use a full-coverage self-adhered underlayment, commonly referred to as peel-and-stick, directly to the roof deck material.
2. At time of reroofing, use a self-adhere product, commonly referred to as seam tape, on all joints and seams of the roof decking material. This still requires nailed down underlayment such as felt paper; or
3. If not replacing the roof, install a foam adhesive used in the attic space which seals every seam of the roof deck and on either side of the trusses or rafters.
