This Initial Inspection Report was prepared by [WCE].

Case No.

Initial Inspection Date

Form DFS-O1-002; Initial Inspection Report  
Rule 69J-7.001, F.A.C.; Effective 10/25

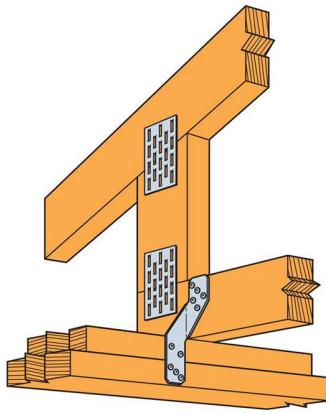
**Clip**

- Secured to truss/rafter with a minimum of three (3) nails; AND
- Attached to the wall top plate of the wall framing, or embedded in the bond beam, with less than a  $\frac{1}{2}$ " gap from the blocking or truss/rafter and blocked no more than 1.5" of the truss/ rafter, and free of visible severe corrosion.
